## Early LNG Experience in the US

Theodore Lemoff  
NFPA

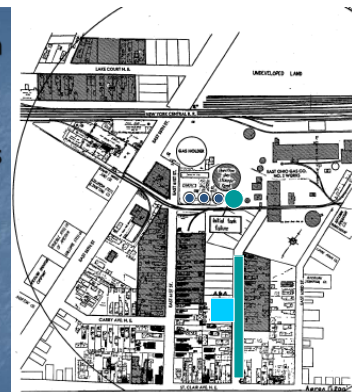
- Liquid ran down 62nd St. – entered sewers
- Vapor in sewers mixed with air and ignited
- Innumerable sources of ignition nearby i.e., labs, meter shop, homes

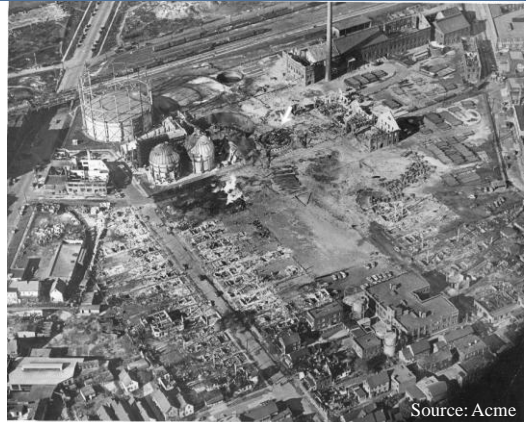
- The LNG tanks were filled, and topping-off was in progress
  - At about 2:00 PM shut-down began
- At 2:40 PM tank # 4 failed
  - Observers at AGA Labs, 180 m S saw vapor/liquid prior to tank collapse
  - Slight earth tremor reported
  - Fire observed
- 1.1 Million gallons (4,800 m<sup>3</sup>) of LNG released
