## Early LNG Experience in the US

Theodore Lemoff  
NFPA

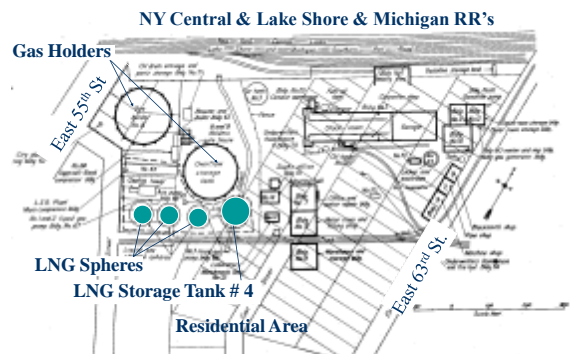
Plan view of No. 2 Works, East Ohio Gas Co, Cleveland, Ohio

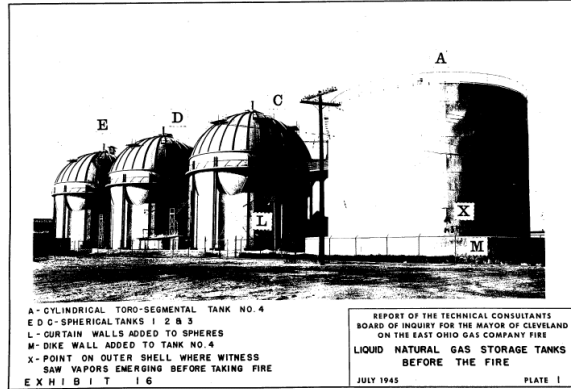
- Tank Dimensions:
  - Inner Tank: 42 ft (13 m) high, 70 ft (21 m) Diam.
  - Outer Tank: 51 ft (16 m) high, 76 ft. (23 m) Diam.
  - Insulation: 3 ft (1 m) Rockwool
- Tank Support:
  - Circular footings, 34 ft (10 m) & 70 ft (21 m) Diam
  - 30 12 in x 12 in (300 x 300 mm) Douglas fir posts

- Initial cooling of Tank # 4 via fill line
- Resulted in a crack in the bottom
  - Crack entirely in one plate
  - Repaired by cutting section of plate & replacement
- Added 3/4 in. (19 mm) copper tubing rings
  - Holes to disperse liquid
  - Additional thermocouples for monitoring
- Second cool-down successful
